BRETT AQUALINE TECHNICAL BULLETIN

BL-40 COMBO VALVE RELAY WIRING ERROR

April 30, 1999

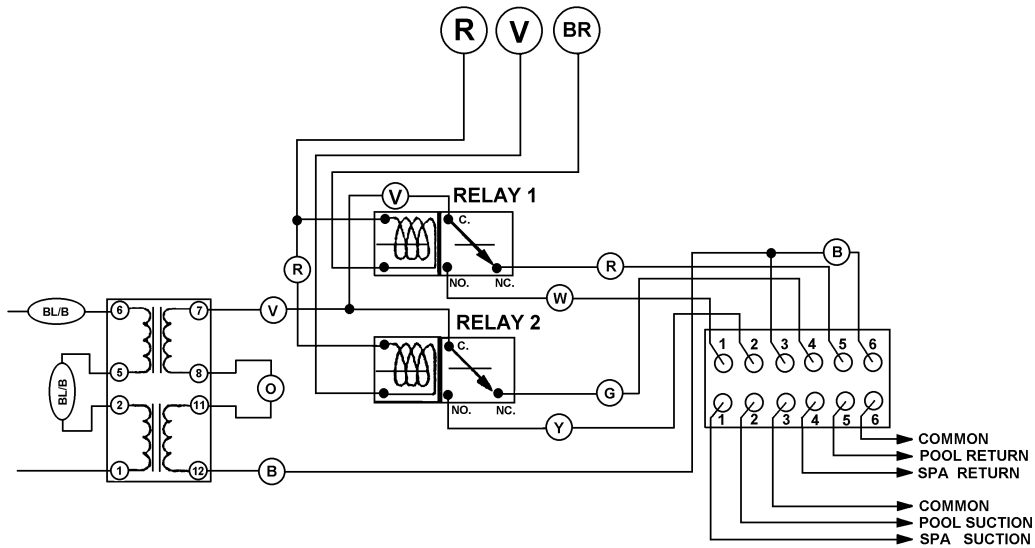
BL-40 COMBO CORRECT VALVE WIRING DIAGRAM

A small percentage of BL-40 Combo units may have a valve relay wiring error which may prevent the pool and spa valves from operating upon initial startup.

Should one of these units have valves that fail to operate properly upon startup, check the factory "pool suction" and "spa return" wiring. The correct wiring should be "POOL SUCTION" (yellow wire) connected to the valve relay's Normally Open (N.O.) terminal and the "SPA RETURN" (green wire) connected to the valve relay's Normally Closed (N.C.) terminal. The correct valve wiring is shown below.
